3.2.a. GENERAL DESCRIPTION

3.2.b. ARCHITECTURAL EXTERIOR

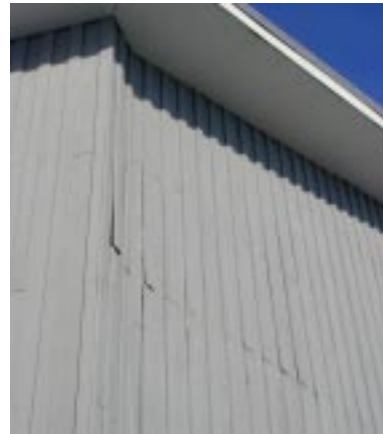
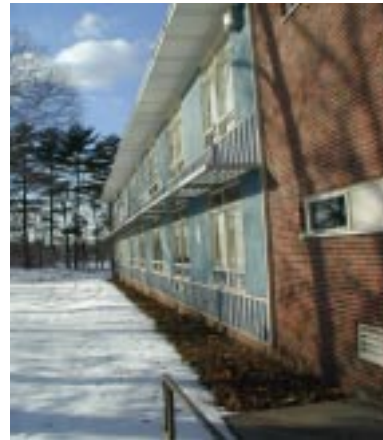
In 1985 a large portion of the windows were covered with painted wood panels. These panels must be painted and repaired constantly. The remaining windows are existing single pane, wood and/or steel sash which are in poor condition. There is some brick veneer which is in good condition.

Remove all of the wood panelling and underlying wood/steel windows. Replace all windows with thermal aluminum windows. Limit the amount of glass at some exposures to reduce heat build up. Tinted glass should be considered. Increase the amount of operable vents to improve ventilation. Where wood panelling is located away from glass areas, remove and replace with panels which provide more thermal resistance and require less maintenance. Provide general masonry repairs/restoration, including caulking at all exposed masonry.

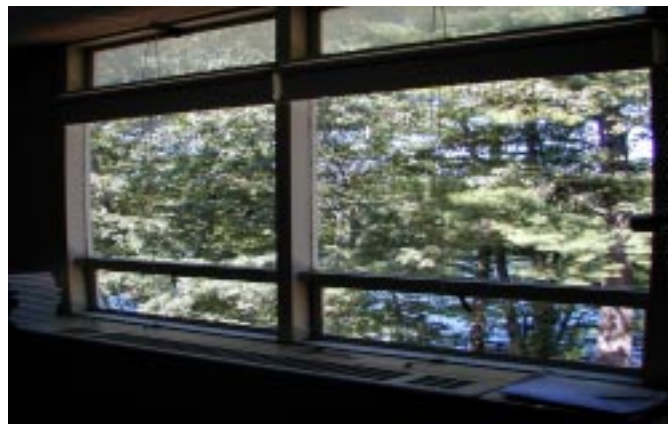
Doors - Most exterior doors have been replaced since 1985 and are generally fiberglass. Many have been recently recoated.

Repair existing fiberglass doors. Replace any heavily utilized doors with new fiberglass. Replace all existing windows as described in 3.2.b.1.

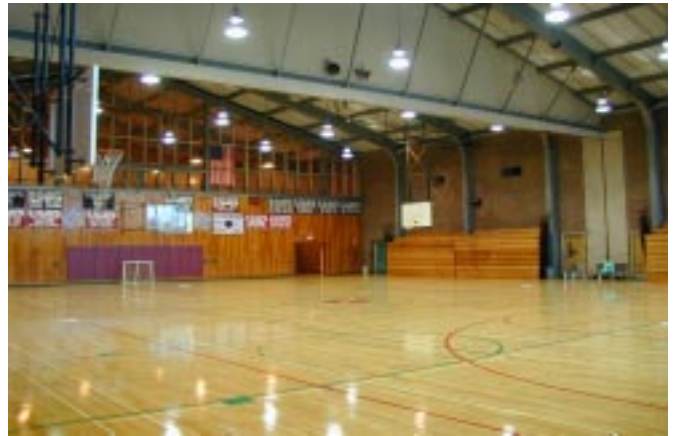
The classrooms, cafeteria and corridors are predominantly vinyl tile floors, installed in 1985. Gym floors are wood, locker and toilet rooms are ceramic tile, auditorium has carpeted aisles, painted concrete at seats and wood at the stage. The administrative area and library are carpeted.

Repair/refinish all wood floors. Replace any existing vinyl asbestos tile (VAT) floors with new resilient flooring. Replace existing vinyl composition tile (VCT) and rubber floor where they are not wearing well. Replace existing carpet.

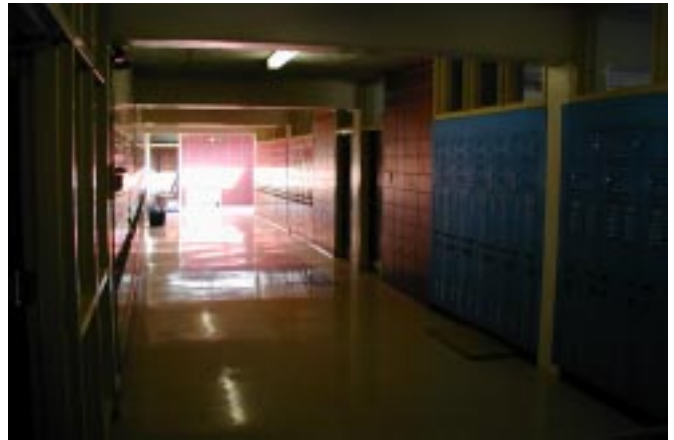
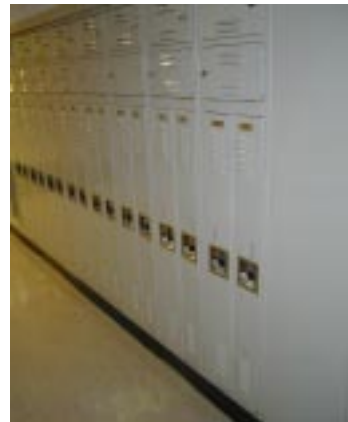
Corridors are predominantly glaze coated masonry, recessed lockers and tectum. Classrooms have glazed tile, unfinished masonry, painted block and painted plaster. Toilets are either ceramic tile or glaze coated masonry blocks.

Repair and resurface all walls where repair is required, where renovation is to take place or where in need of improvement. This will cover most walls throughout the building.

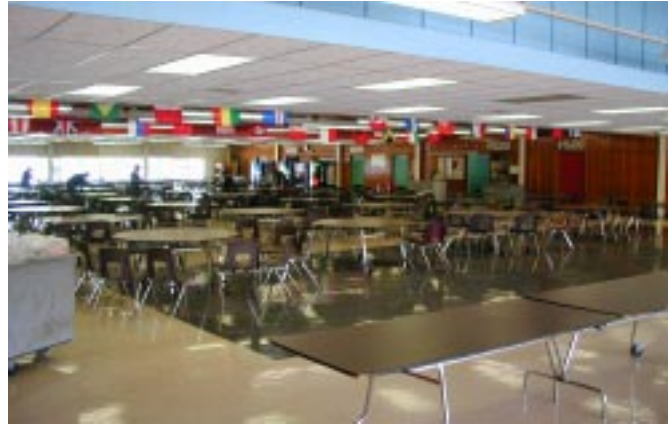
Many of the ceilings are 2 x 4 tectum ceiling panels in a suspended grid. The exposed painted concrete structure exists at the 1964 classroom additions. Many rooms have original 1 x 1 ceiling tile.

Because a new sprinkler system is required, the HVA C system must be upgraded and new lighting is to be installed, all ceilings should be new acoustical suspended ceilings.

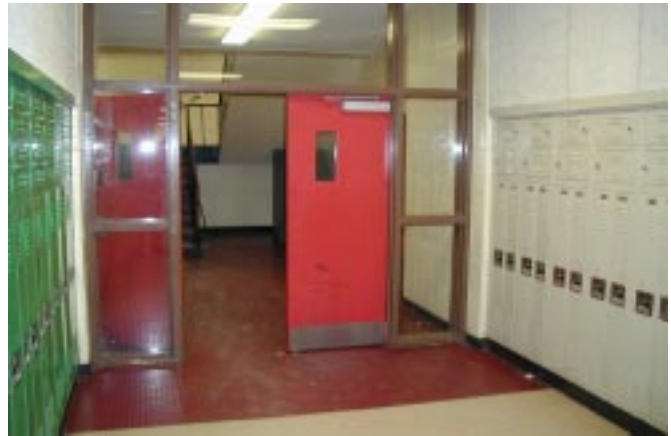
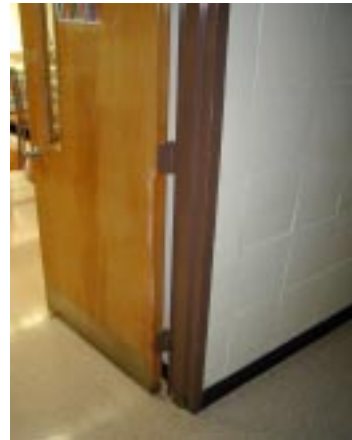
Although the doors have been maintained, they are wearing and in some cases the wood doors are falling apart to the point that they do not operate properly.

High impact, heavily used doors should be replaced. Magnetic holders should be installed to increase the life expectancy of the doors. A complete survey of every door should be done to evaluate the condition of the door, frame and hardware, repair and replace as required. For the purpose of this study, an assumption is made that 75% of the doors will require minor to major repair/replacement. Access for handicapped must be considered and wider, accessible doors and hardware installed.
