3.3.a GENERAL DESCRIPTION

3.3.b Findings

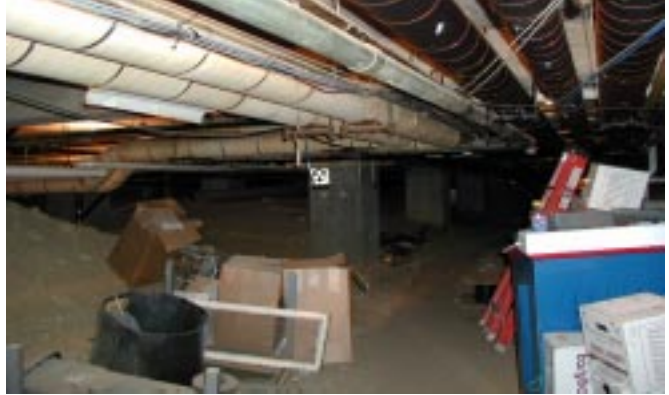
Picture 1

- Pipe and hard joint insulation (pic #1)
- Stage fire curtain
- Tank insulation
- Duct insulation
- Boiler insulation
- Floor tile mastic
- Transite panels

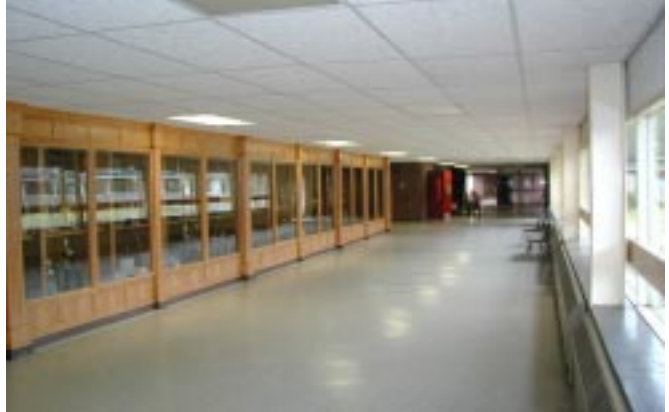
Picture 2

- Mastic for beige 12" x 12" vinyl floor tile at S Wing
- Green 12" x 12" vinyl floor tile at main corridor by gymnasium (pic #2)
- Mastic for green 12" x 12" vinyl floor tile at main corridor by gymnasium

<u>Type of Material</u>	<u>Sample Results</u>
• Green 12" x 12" vinyl floor tile at main corridor by gymnasium	4% Asbestos Chrysotile
• Glue daub for 1' x1' acoustical ceiling tile above Tectum ceiling	<1% Asbestos Chrysotile

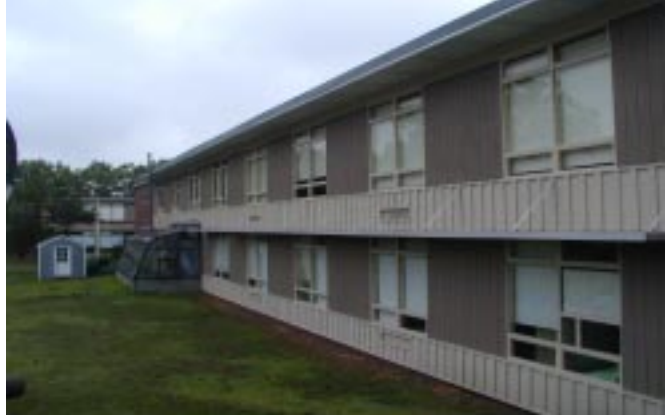
Picture 3

- Exterior vertical caulking in blue wood siding at front of school
- Exterior window framing putty (pic #3)
- Interior window framing putty at boiler room
- Unit vent grille caulking
- Door framing putty
- Soft ceiling plaster at auditorium
- Soft ceiling plaster at girl's room
- Dampproofing on walls at gymnasium air room
- Black mastic under fiberglass insulated duct air gymnasium air room
- Black mastic under fiberglass on ceilings in crawl space air room
- Mastic on tabs on fiberglass on ceilings in crawl space air room
- Black mastic under fiberglass insulated duct at crawl space

• Exterior window framing putty	6% Asbestos Chrysotile
• Interior window framing putty at boiler room	3% Asbestos Chrysotile
• Unit vent grille caulking	5% Asbestos Chrysotile
