3.2.a. GENERAL DESCRIPTION

3.2.b. ARCHITECTURAL EXTERIOR

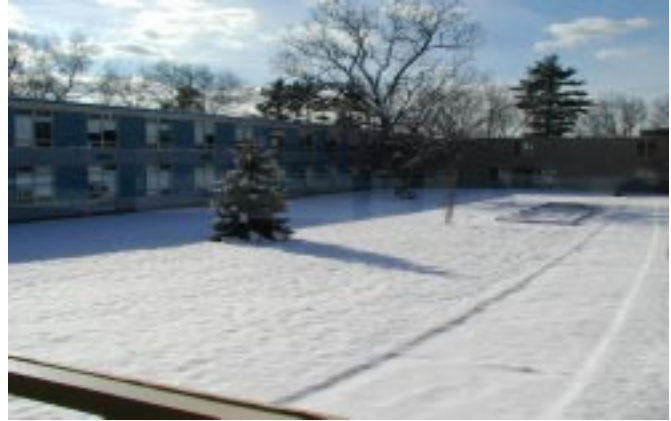
The original 1954 building consists of (2) two-story classroom wings with flat roofs, a two-story library with a shallow sloped roof, a one story administration office wing and the large 45' high +/- gymnasium and auditorium. The 1964 additions are similar to the original building. The classroom additions are two-story with flat roofs, one with brick walls the other with windows and panels similar to the original building. The library, gymnasium and cafeteria expansions provided similar roof lines and materials to the original building.

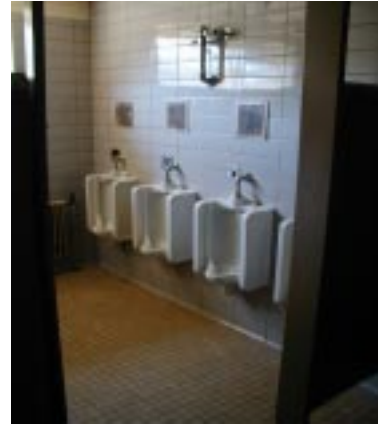
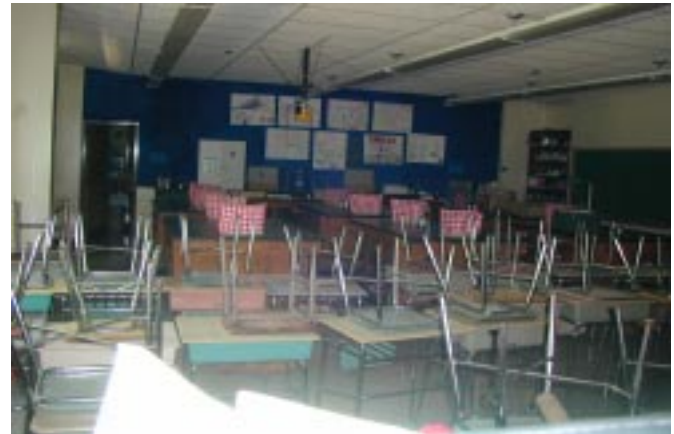
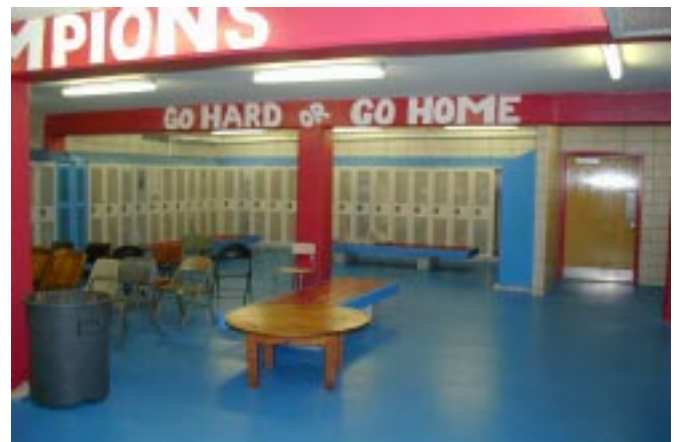
Upon visual inspection, all portions of the building appear to be very sound and well constructed. According to the Sixth Edition of the State Building Code, Chapter 34, paragraph 3408.0, Structural Requirements for Existing Buildings, seismic provisions would have to be made to the existing building in the event that a major renovating project, such as the project recommended in this report, is proposed. Particular modifications required to conform to the seismic requirements, include eliminating any seismic hazards, such as ensuring that the brick veneer is properly anchored to the structure. This condition would have to be addressed along the exterior walls of the classroom wings of the original 1953 building. The exterior walls at the stage would have to be braced as well. This could be achieved fairly easily by installing steel beams along the inside face of the masonry connected to the exposed steel framing. Additionally, all non-bearing interior masonry walls must be anchored to the ceiling or floor structure. Hazards, such as unbraced parapets, must be reviewed. The only area where this was observed is over the stage and it would be recommended to simply remove the parapet if the renovation work proceeds.
