### Hot Water

#### Natural Gas

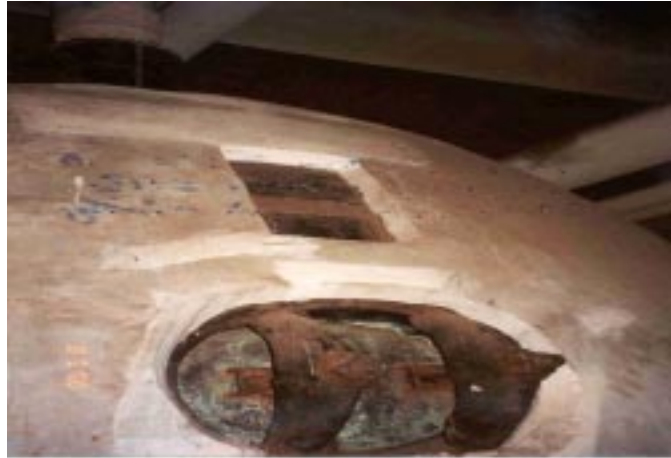
Picture 1

- Approximate capacity of each tank is 500 gallons
- Hot water during the heating season is off the main steam boilers
- Both storage tanks are beyond their life expectancies by a wide margin - the steam coils are partially blocked, the control valve is not functioning properly and the bottoms of the tanks are corroded. (pic #1)

- Replace existing hot water storage tanks with two (2), 400 Gallon storage, 800 Gallon per hour recovery, Dual Fuel (Gas and Steam ) water heaters and connect to the existing distribution system
- Hot water to be stored at 160°F.
- Provide Triplex High - Low Capacity Thermostatic Mixing Valve assembly to distribute general use hot water at 140° ) with tapping on the supply side for future dedicated line (160°F) to kitchen. (Lavatories in toilets to be provided with thermostatic/ limit stop, metered, mixing valve that can be set for a maximum delivery temperature of 110°F (Code mandated for Public Lavatories.).

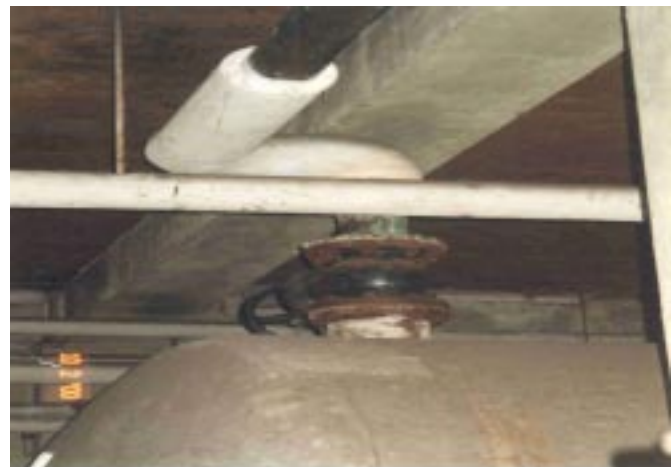
Picture 2

- The steam system is jury rigged by means of a remote sensor to an on-off operation
- The hot water distribution system and recirculation system that runs through the Crawl / Tunnel spaces is not insulated (pic #2)

- Provide an electric, heat maintenance tape system for entire hot water system in lieu of existing circulation system to allow for proper operation of the required low flow Lavatory faucets.
- Insulate the existing Hot Water Distribution piping
- Provide inter - tank circulators for all water heaters to eliminate stacking problem common to heat tape systems
- Install new Electric water heater (estimate at 40-Gallon storage, 4.5 KW) in S wing to serve all Laboratory Hot water requirements (at sinks). Requires separation of Lab hot water supply from existing domestic hot water supply and re-piping as required.
- Install an additional Fail Safe Thermostatic Mixer (for 80°F tempered water) and re-pipe direct to all Emergency Showers and Eyewashes per code. (Hot water supply from the Domestic Hot Water system not the electric water heater for lab sinks)

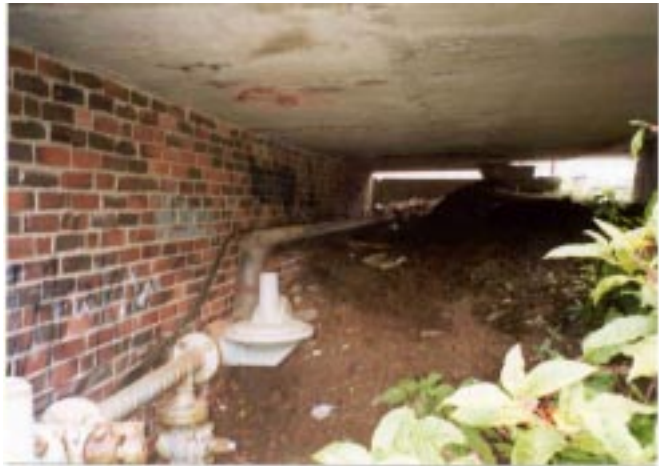
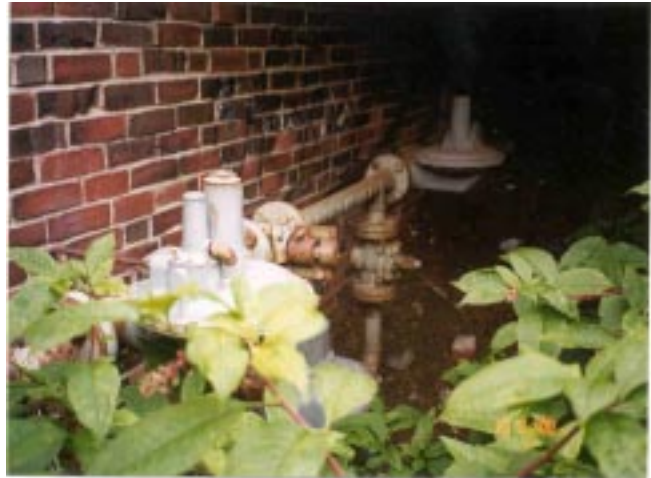
- The School is fed by what appears to be an intermediate pressure line as there is pressure reduction at the meter set and it also feeds boiler #1 and the Emergency Generators, which typically require a gas pressure of 11" WC. The interior portion of the gas service at the main mechanical room is 4" diameter. (pics #3 & 4)

- The Emergency Generators (4) are presently fed off the same line that feeds the Summer Boiler and appear to also feed the Science wing labs. Present code requires that a dedicated line, from the meter, feed Emergency Generators.

- Provide new connections and piping for the Proposed Dual Fuel (Gas and Oil) Fired Boilers and Gas fired Water heaters and re-feed existing gas distribution system to labs
- Provide new regulator gas vents from new water heaters, and proposed Boilers to exterior
- Increase service to the school to accommodate Gas Fired Boilers for the space-heating portion of the building.

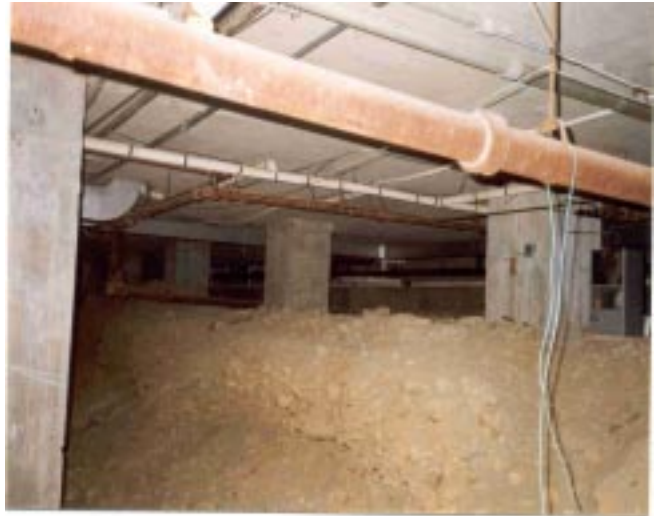
Picture 5

- The cast iron Hub and spigot piping in the crawl space areas is starting to deteriorate and leaks are beginning to become a re-occurring maintenance issue - the piping in the tunnel areas is in better condition. (pic #5)

- Replace all Cast Iron drain piping within crawl space portions of the building.

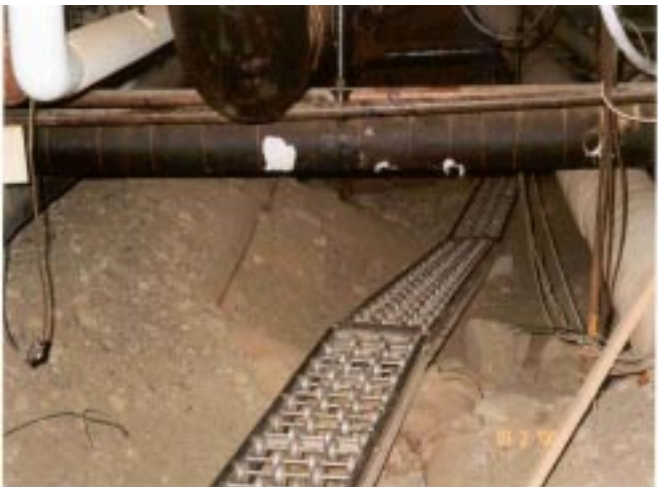
Picture 6

- The S wing is presently the dedicated area for Labs that would require treatment of corrosive wastes. Presently all the lab sinks are piped with either mechanical joint Polypropylene (in the crawl space areas) or a Pyrex Glass system for the above floor system to two Limestone chip tanks in the crawl space which in turn discharge to the Sanitary sewer line in the immediate area.
- The chip tanks are routinely inspected and Limestone chips are added as necessary - aside from a layer of floating sediment at the top of the tanks there is typically minimal maintenance required for the tanks due to a reduction of chemicals for teaching purposes

- Install pH-monitoring equipment with Chart Recorders on discharge side of Neutralization tanks in Crawl space
- Provide better access to the area of the neutralization tanks for maintenance and monitoring of the system (pic #6)

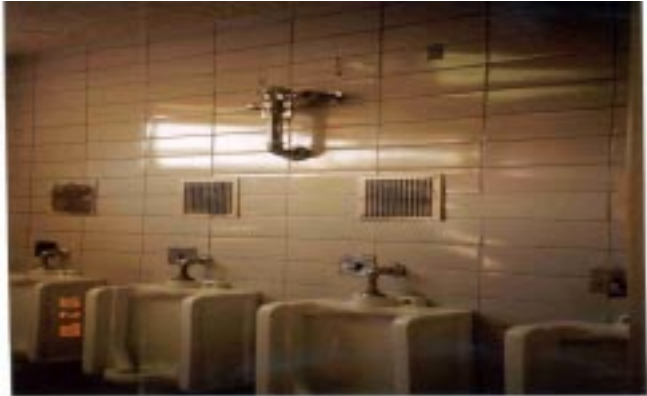
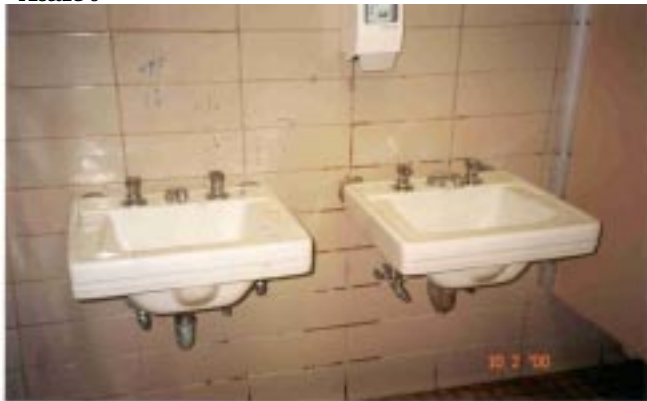
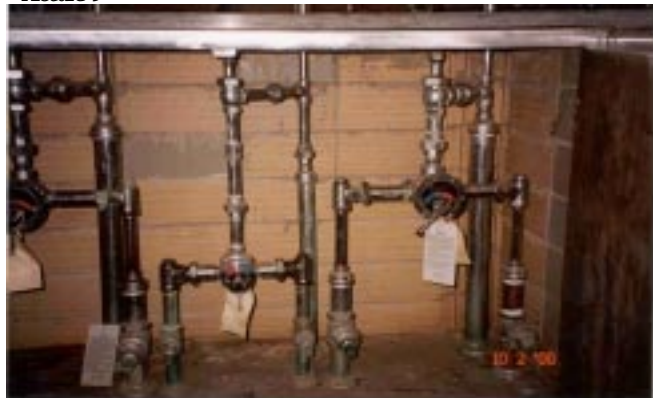
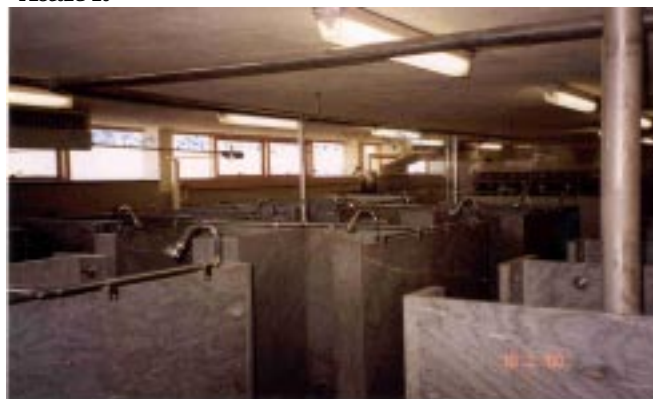
- All plumbing fixtures observed during walk-through appear to be original to the buildings and will require replacement to comply with current plumbing code as to accessibility under ADA/AAB requirements, Low flow restrictions, and maximum allowable hot water delivery temperature. (pics #7 & 8)
- Individual Master thermostatic mixers in each Shower room presently control showers in the Locker Rooms. Shower rooms for the Boys are gang showers with drainage to the exterior walls in accordance with code. Girl's side is comprised of individual stalls - control of the showerheads and final delivery temperature as well as on-off operation varies in each room. (pics #9 & 10)

- Replacement of all fixtures and related controls during renovation along with Replacement of existing showers in locker rooms with 2.5 GPM heads and pressure balanced mixing valves for final, point of use, temperature control
